**Flood Control Project Maintenance  
Levee Inspections**

**Fall 2013 Levee Maintenance Deficiency Summary Report**

**San Joaquin River Basin**

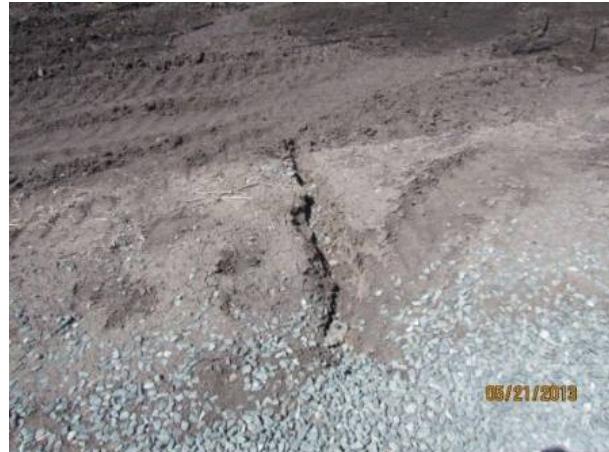
Levee Mile Report Line	5
Start Levee Mile	0.39
End Levee Mile	0.39
Location	Land Side
Category	Earthen Levee
Item	Erosion / Bank Caving
Erosion was found on the landside of the levee looking downstream.	
pkazi_f_20131001_005.JPG

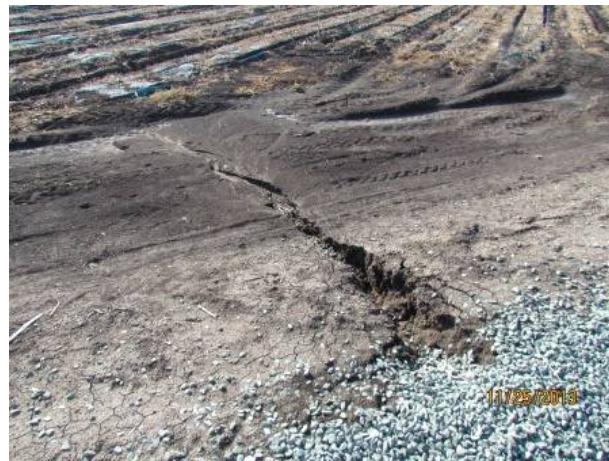
Levee Mile Report Line	5
Start Levee Mile	0.39
End Levee Mile	0.39
Location	Land Side
Category	Earthen Levee
Item	Erosion / Bank Caving
Updated picture of the erosion due to runoff on the landside of the levee looking downstream.	
pkazi_f_20131126_096.JPG

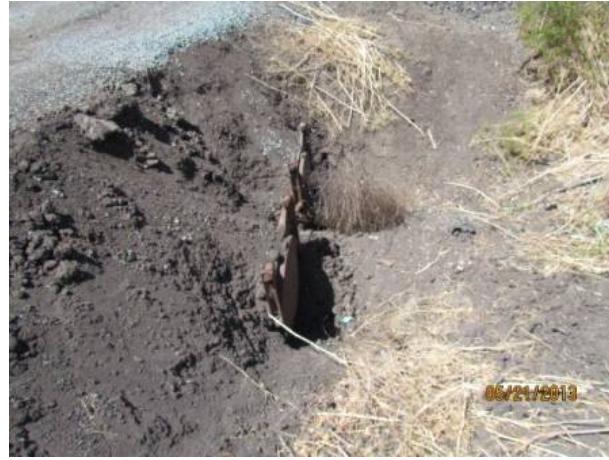
Levee Mile Report Line	6
Start Levee Mile	1.05
End Levee Mile	1.05
Location	Water Side
Category	Interior Drainage & Piping Systems
Item	Flap Gates
The flap gates are clear of debris and the PVC pipe is taken out by the LMA. The picture was taken from waterside toe of the levee looking downstream.	
pkazi_f_20131001_007.JPG

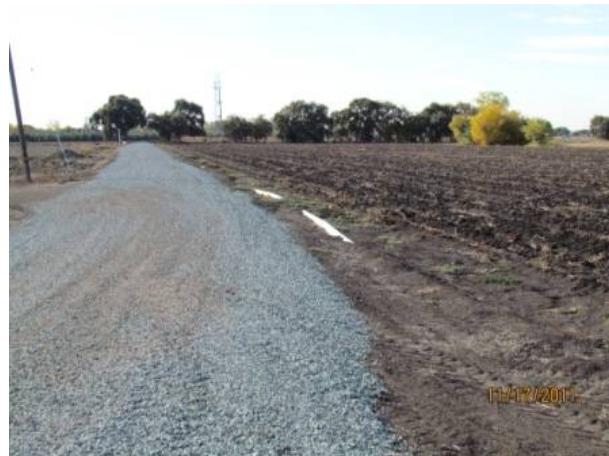
Levee Mile Report Line	7
Start Levee Mile	1.07
End Levee Mile	1.27
Location	Water Side
Category	Earthen Levee
Item	Encroachments
PVC Pipe was found on the waterside of the levee looking downstream.	
pkazi_f_20131001_004.jpg

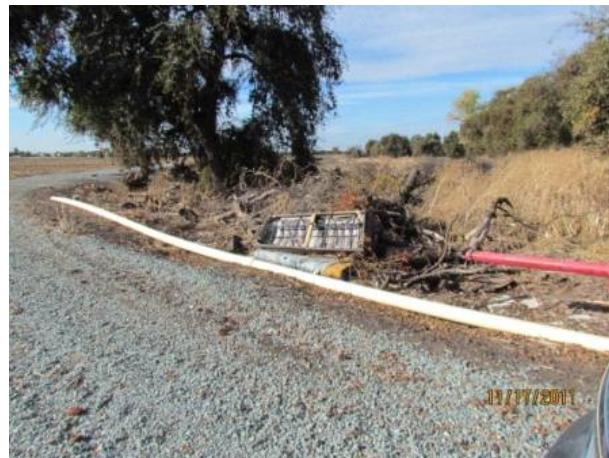
Levee Mile Report Line	8
Start Levee Mile	1.28
End Levee Mile	1.28
Location	Water Side
Category	Earthen Levee
Item	Encroachments
Debris was found on the waterside of the levee looking downstream.	
pkazi_f_20131001_003.jpg

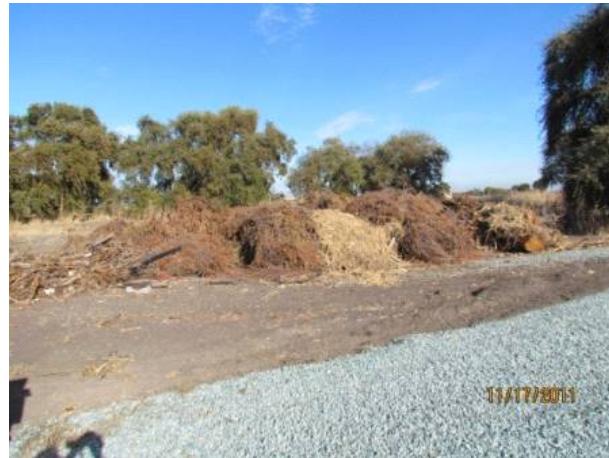
Levee Mile Report Line	9
Start Levee Mile	1.32
End Levee Mile	1.32
Location	Water Side
Category	Earthen Levee
Item	Encroachments
Prunings were found on the waterside of the levee looking upstream.	
pkazi_f_20131001_006.jpg

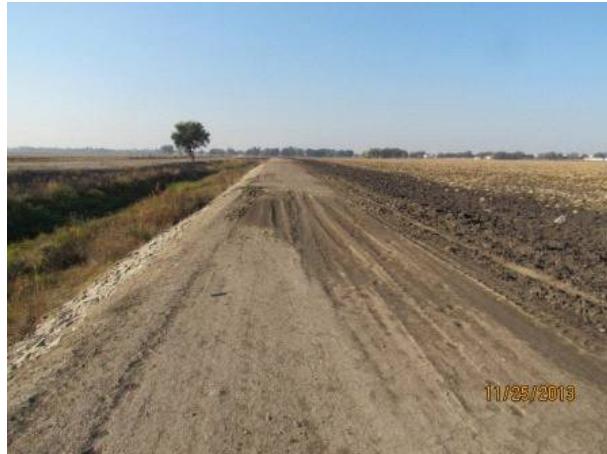
Levee Mile Report Line	4
Start Levee Mile	2.01
End Levee Mile	2.01
Location	Crown
Category	Earthen Levee
Item	Crown Surface / Depressions / Rutting
Crown depression was found looking downstream.	
pkazi_f_20131126_097.JPG

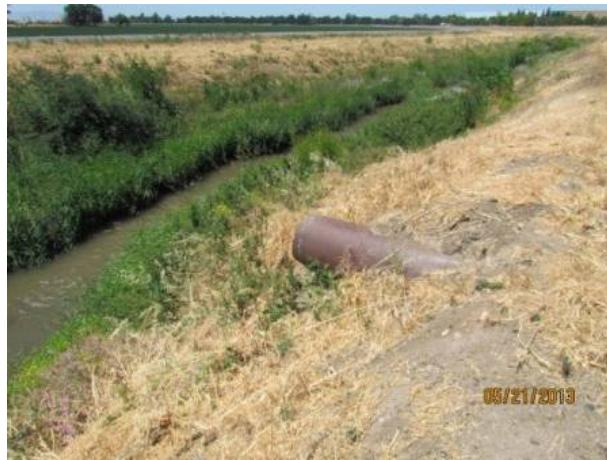
9	2.66	2.66	Earthen Levee	Encroachments	WSA/W	PI	Pipe Ma Inspector Comments: Pipe crossing the channel has corroded and can carry water to/from the channel. This pipe needs immediate attention but is likely an older encroachment and may predate the project.	37.888853 °	37.888853 °	8	
								-121.258640 °	-121.258640 °	Y	
								DWR ID: DWR_NA0017_02_s_2012_8

Levee Mile Report Line	9
Start Levee Mile	2.66
End Levee Mile	2.66
Location	Water Side
Category	Earthen Levee
Item	Encroachments
A pipe was found without a flap gate on waterside slope of the levee looking downstream. This pipe may predate the project.	
pkazi_f_20131001_012.JPG

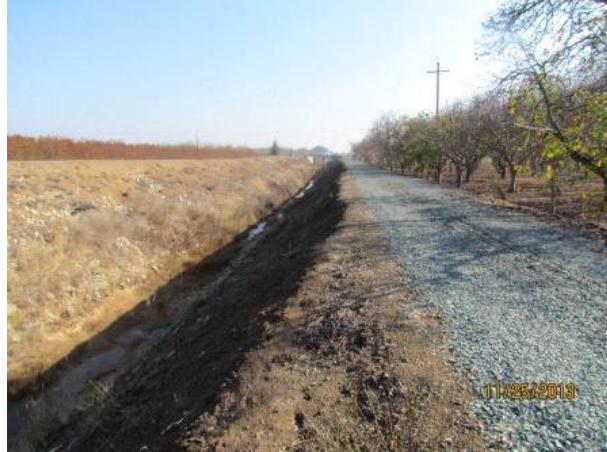
Levee Mile Report Line	1
Start Levee Mile	0.40
End Levee Mile	0.40
Location	Water Side
Category	Earthen Levee
Item	Vegetation
View of the waterside of the levee looking upstream.	
pkazi_f_20131126_089.JPG

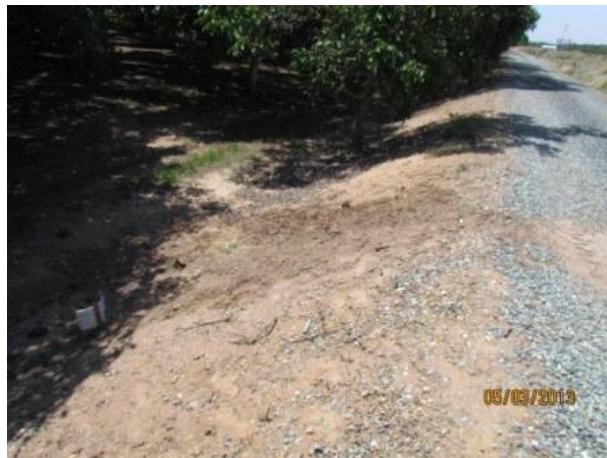
Levee Mile Report Line	2
Start Levee Mile	0.45
End Levee Mile	0.45
Location	Land Side
Category	Earthen Levee
Item	Slope Stability
Slope instability was repaired by the LMA on the landside slope of the levee looking downstream.	
pkazi_f_20131001_016.JPG

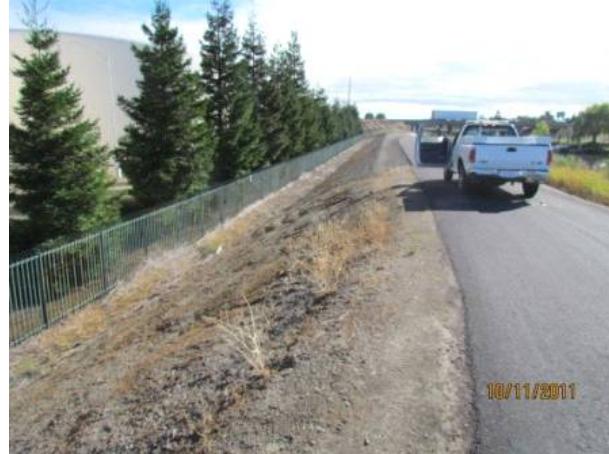
Levee Mile Report Line	1
Start Levee Mile	0.39
End Levee Mile	0.50
Location	Land Side
Category	Earthen Levee
Item	Encroachments
View of the fence along landside toe of the levee looking upstream.	
pkazi_f_20131001_017.jpg

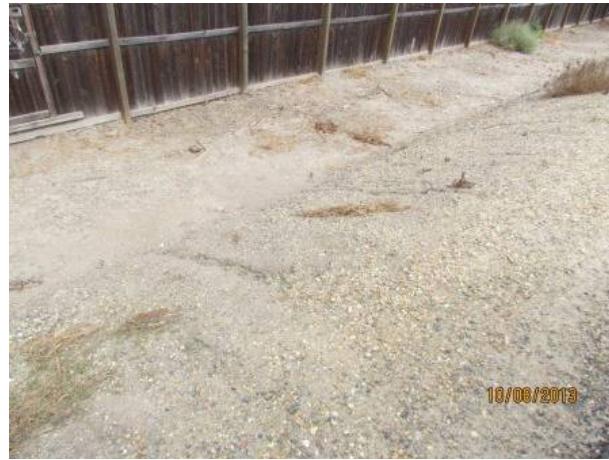
Levee Mile Report Line	3
Start Levee Mile	1.17
End Levee Mile	1.17
Location	Land Side
Category	Earthen Levee
Item	Erosion / Bank Caving
Runoff was discovered on the landside slope of the levee looking upstream.	
pkazi_f_20131019_938.JPG

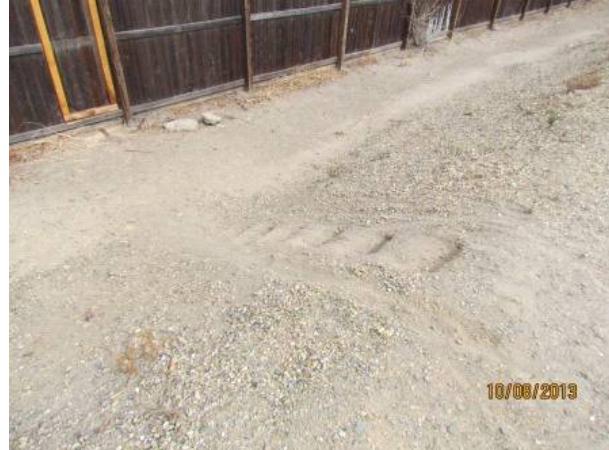
Levee Mile Report Line	4
Start Levee Mile	1.23
End Levee Mile	1.23
Location	Land Side
Category	Earthen Levee
Item	Encroachments
Stairs were dug on the landside slope of the levee looking upstream.	pkazi_f_20131019_939.JPG

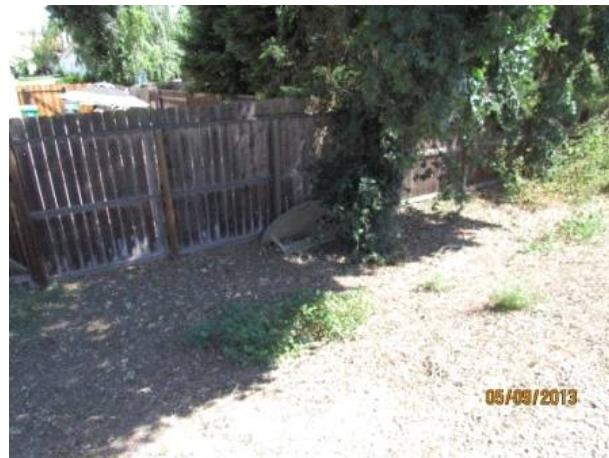
Levee Mile Report Line	5
Start Levee Mile	1.54
End Levee Mile	1.54
Location	Land Side
Category	Earthen Levee
Item	Encroachments
Debris was found on the landside toe of the levee looking upstream.	pkazi_f_20131001_019.JPG

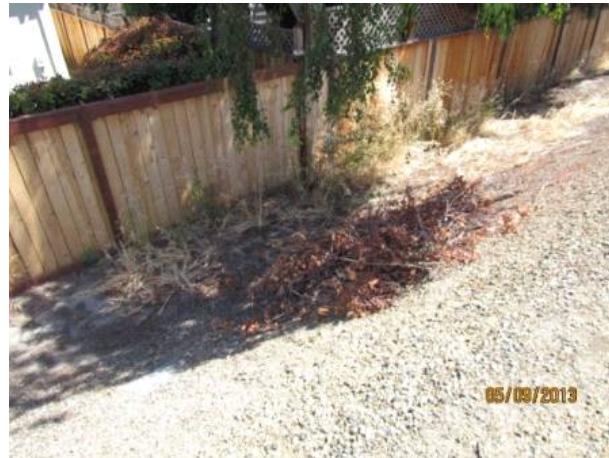
Levee Mile Report Line	6
Start Levee Mile	1.90
End Levee Mile	1.90
Location	Land Side
Category	Earthen Levee
Item	Encroachments
Prunings were found on the landside of the levee looking upstream.	pkazi_f_20131001_056.JPG

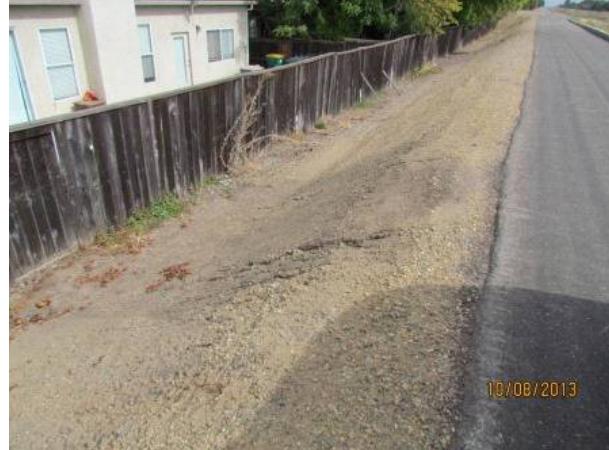
Levee Mile Report Line	7
Start Levee Mile	1.94
End Levee Mile	1.94
Location	Land Side
Category	Earthen Levee
Item	Erosion / Bank Caving
Runoff was discovered on the landside slope of the levee looking upstream.	
pkazi_f_20131019_940.JPG

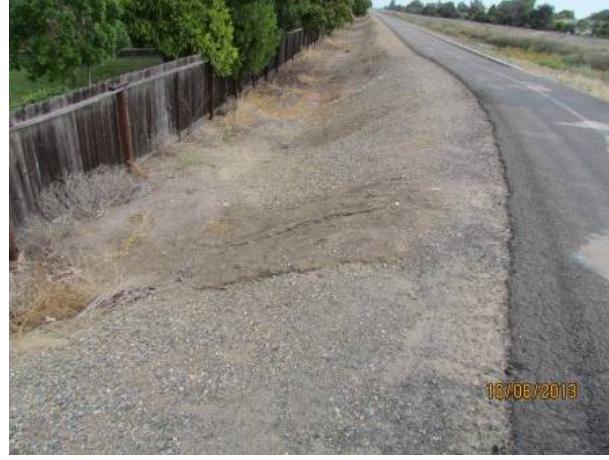
Levee Mile Report Line	9
Start Levee Mile	2.03
End Levee Mile	2.03
Location	Land Side
Category	Earthen Levee
Item	Erosion / Bank Caving
Runoff was found on the landside of the levee looking upstream.	
pkazi_f_20131019_941.JPG

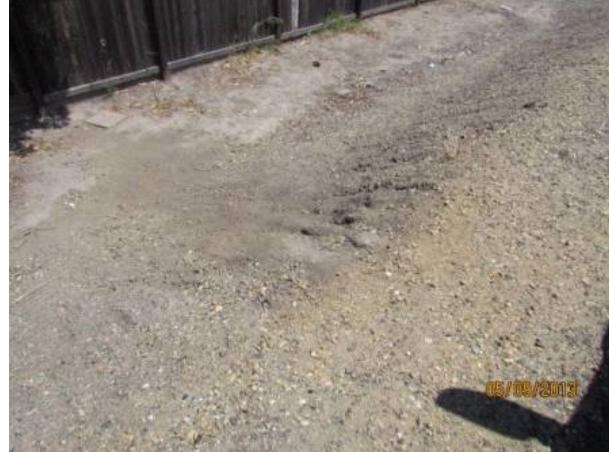
Levee Mile Report Line	10
Start Levee Mile	2.08
End Levee Mile	2.08
Location	Land Side
Category	Earthen Levee
Item	Erosion / Bank Caving
Erosion was found on the landside of the levee looking upstream.	
pkazi_f_20131001_021.JPG

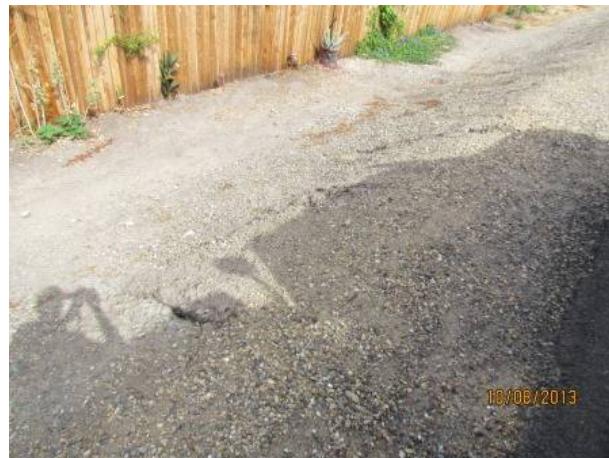
Levee Mile Report Line	12
Start Levee Mile	2.27
End Levee Mile	2.27
Location	Land Side
Category	Earthen Levee
Item	Erosion / Bank Caving
Runoff was found on the landside slope of the levee looking upstream.	
pkazi_f_20131019_942.JPG

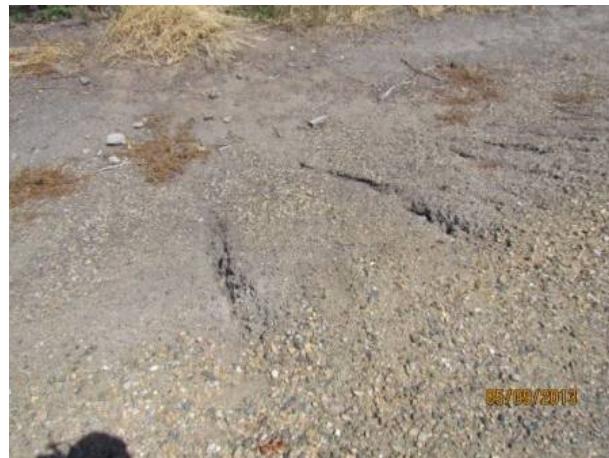
Levee Mile Report Line	13
Start Levee Mile	2.34
End Levee Mile	2.34
Location	Land Side
Category	Earthen Levee
Item	Slope Stability
Erosion caused by runoff was found on the landside of the levee looking upstream.	
pkazi_f_20131001_023.JPG

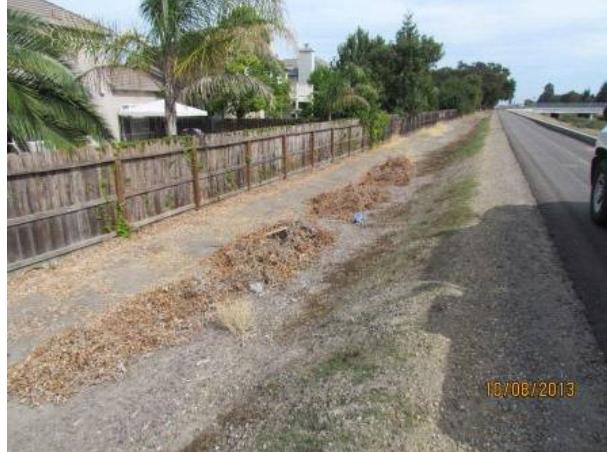
Levee Mile Report Line	14
Start Levee Mile	2.44
End Levee Mile	2.44
Location	Land Side
Category	Earthen Levee
Item	Encroachments
Prunings were found on the landside of the levee looking upstream.	
pkazi_f_20131019_943.JPG

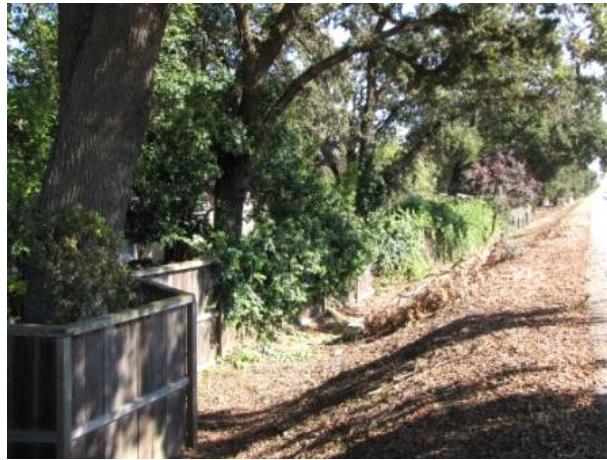
Levee Mile Report Line	17
Start Levee Mile	2.57
End Levee Mile	2.65
Location	Land Side
Category	Earthen Levee
Item	Encroachments
View of a wood fence adjacent to the landward toe looking upstream.	
pkazi_f_20131001_082.jpg

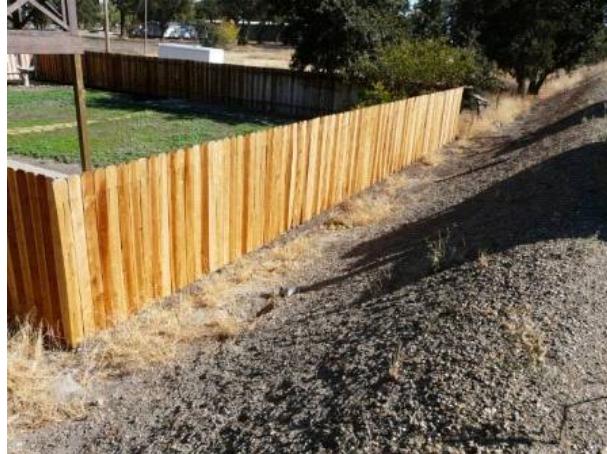
Levee Mile Report Line	18
Start Levee Mile	2.66
End Levee Mile	2.67
Location	Land Side
Category	Earthen Levee
Item	Encroachments
Newer fence built within landside toe of levee at from LM 2.66 to LM 2.67.	
pkazi_f_20131001_031.JPG

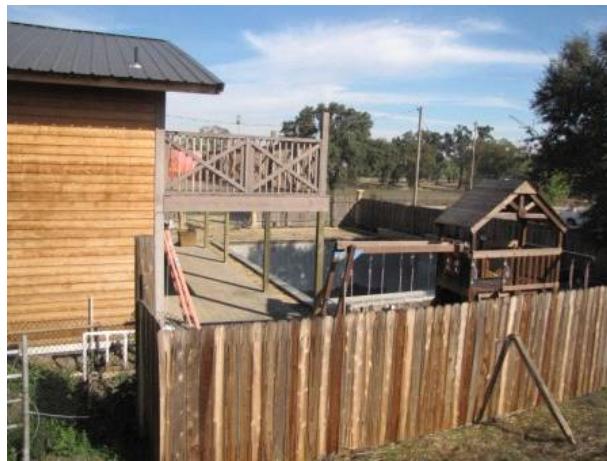
Levee Mile Report Line	19
Start Levee Mile	2.67
End Levee Mile	2.67
Location	Land Side
Category	Earthen Levee
Item	Encroachments
View of a recently constructed pool looking landward.	
pkazi_f_20131001_047.jpg

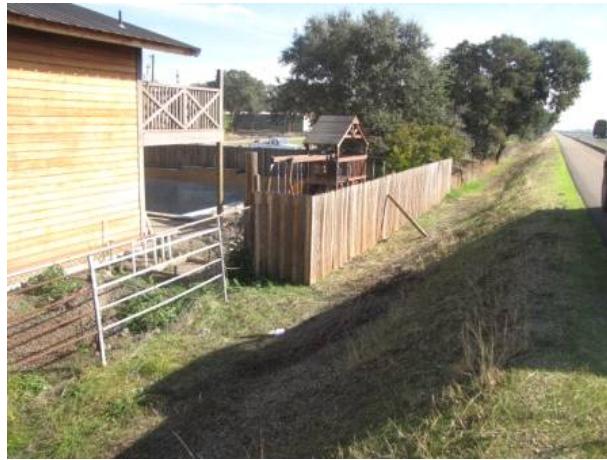
Levee Mile Report Line	19
Start Levee Mile	2.67
End Levee Mile	2.67
Location	Land Side
Category	Earthen Levee
Item	Encroachments
View of a recently constructed pool looking upstream.	
pkazi_f_20131001_048.jpg

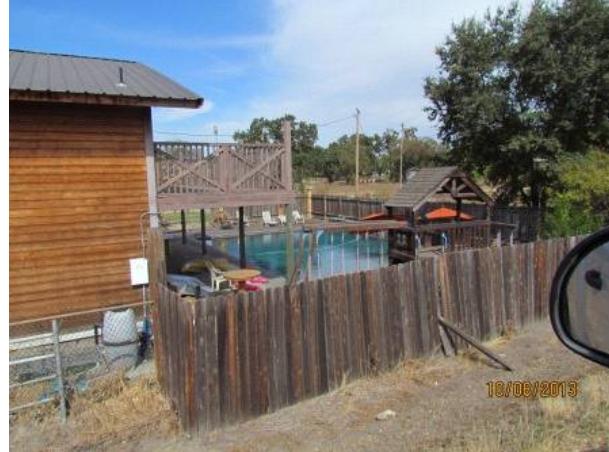
Levee Mile Report Line	19
Start Levee Mile	2.67
End Levee Mile	2.67
Location	Land Side
Category	Earthen Levee
Item	Encroachments
View of the pool on the landside toe of the levee looking upstream during fall 2013 inspection.	
pkazi_f_20131019_945.JPG

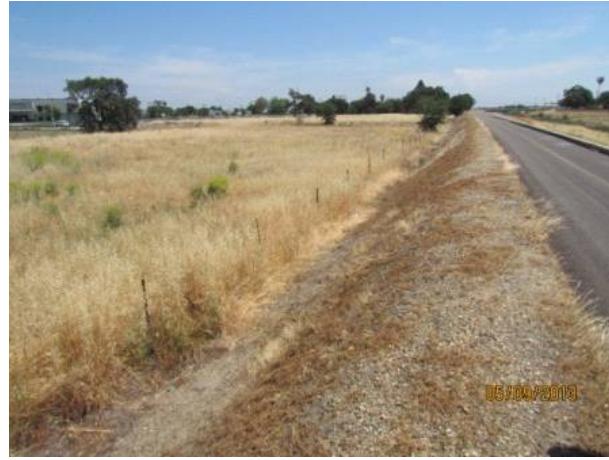
Levee Mile Report Line	21
Start Levee Mile	2.84
End Levee Mile	3.13
Location	Land Side
Category	Earthen Levee
Item	Encroachments
Fences were found on the landside toe of the levee looking upstream.	
pkazi_f_20131001_024.JPG

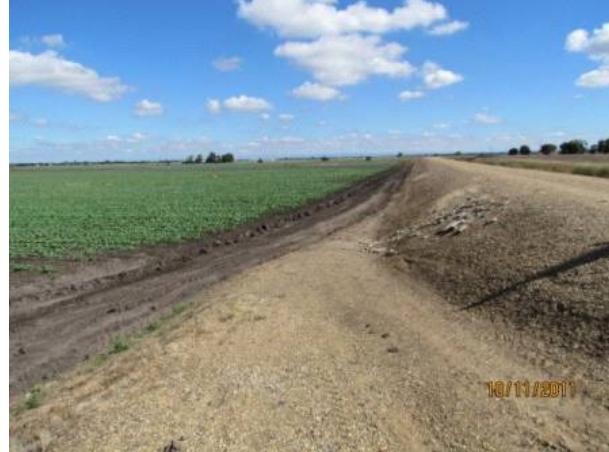
Levee Mile Report Line	22
Start Levee Mile	3.16
End Levee Mile	3.35
Location	Land Side
Category	Earthen Levee
Item	Encroachments
Farmer discing the toe of the landside of the levee looking upstream.	
pkazi_f_20131001_073.jpg

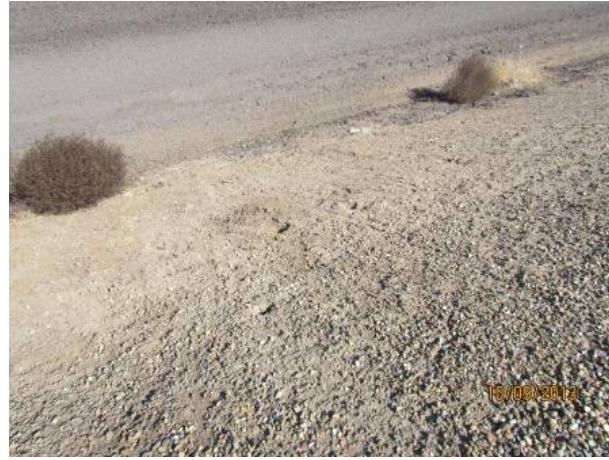
Levee Mile Report Line	24
Start Levee Mile	3.49
End Levee Mile	3.49
Location	Land Side
Category	Earthen Levee
Item	Animal Control
An animal hole was found on the landside of the levee looking upstream.	
pkazi_f_20131019_946.JPG

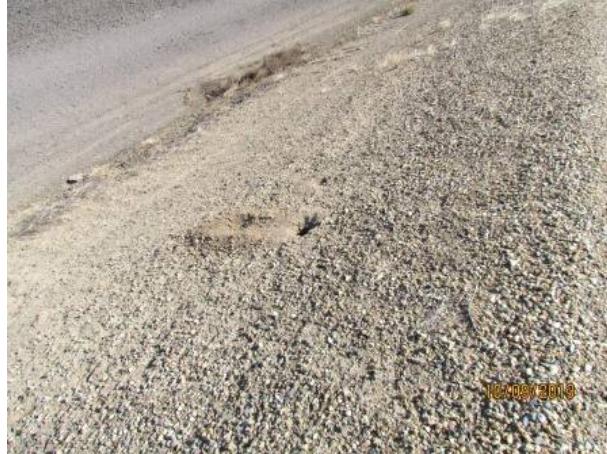
Levee Mile Report Line	25
Start Levee Mile	3.51
End Levee Mile	3.51
Location	Land Side
Category	Earthen Levee
Item	Animal Control
An animal hole was found on the landside of the levee looking upstream.	
pkazi_f_20131019_947.JPG

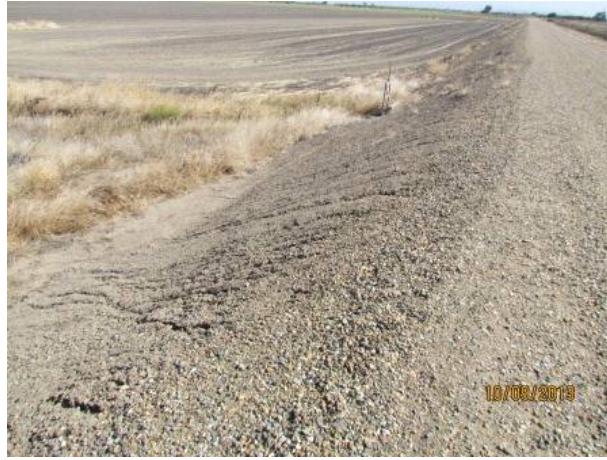
Levee Mile Report Line	27
Start Levee Mile	3.78
End Levee Mile	3.78
Location	Land Side
Category	Earthen Levee
Item	Erosion / Bank Caving
Erosion occurred due to runoff on the landside slope of the levee looking upstream.	
pkazi_f_20131019_949.JPG

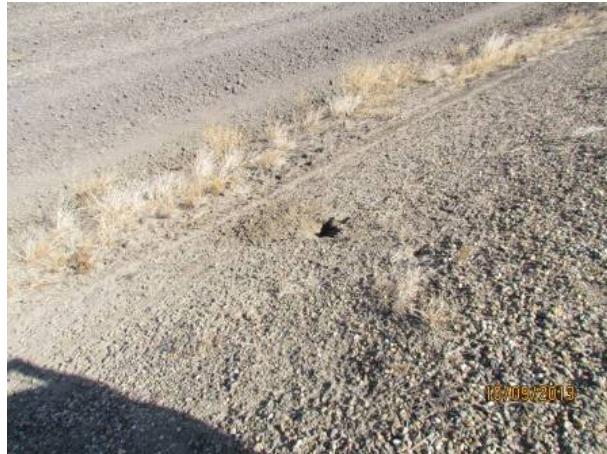
Levee Mile Report Line	28
Start Levee Mile	4.04
End Levee Mile	4.04
Location	Land Side
Category	Earthen Levee
Item	Animal Control
An animal hole was found on the landside slope of the levee looking upstream.	
pkazi_f_20131019_950.JPG

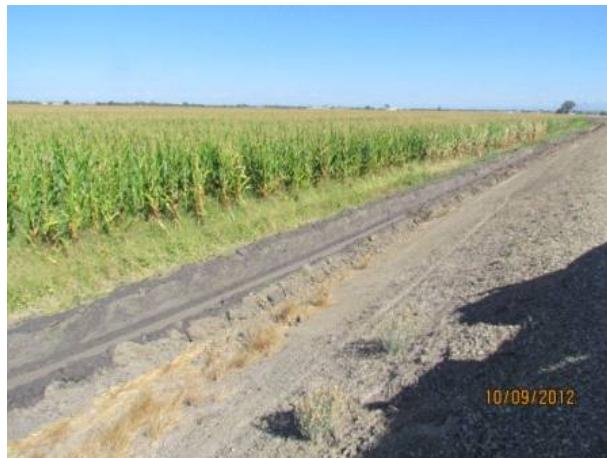
Levee Mile Report Line	29
Start Levee Mile	4.10
End Levee Mile	4.21
Location	Land Side
Category	Earthen Levee
Item	Encroachments
A ditch was found on the landside toe of the levee looking upstream.	
pkazi_f_20131001_057.jpg

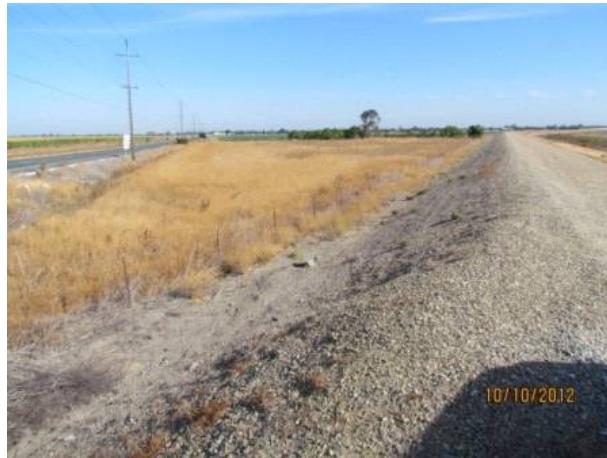
Levee Mile Report Line	31
Start Levee Mile	4.66
End Levee Mile	5.63
Location	Land Side
Category	Earthen Levee
Item	Encroachments
View of the fence on the landside toe of the levee looking upstream.	
pkazi_f_20131001_075.jpg

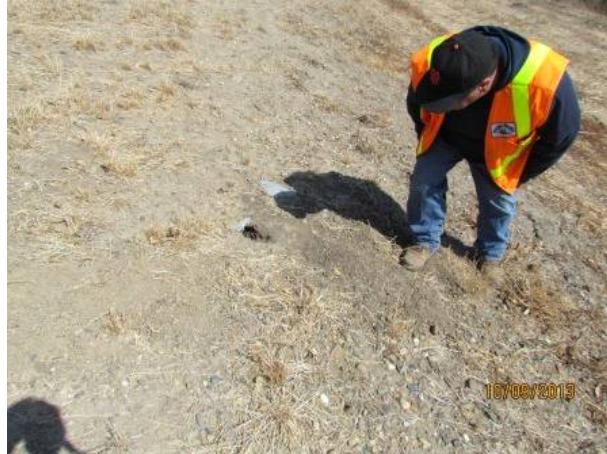
Levee Mile Report Line	32
Start Levee Mile	4.78
End Levee Mile	4.78
Location	Water Side
Category	Earthen Levee
Item	Animal Control
A rodent hole was found on the waterside of the levee looking upstream.	
pkazi_f_20131019_951.JPG

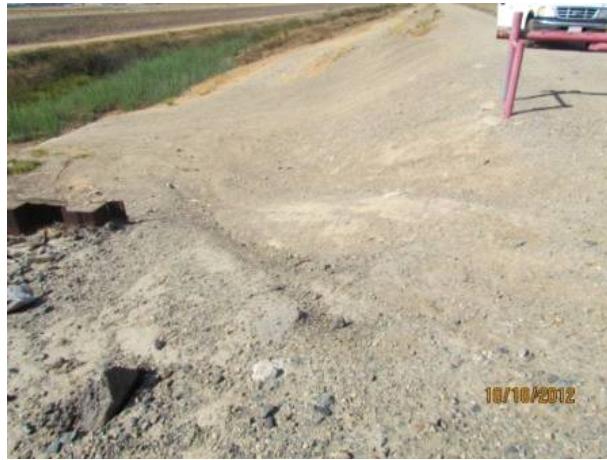
Levee Mile Report Line	37
Start Levee Mile	5.85
End Levee Mile	5.85
Location	Water Side
Category	Earthen Levee
Item	Slope Stability
Slope instability was found on the landside of the levee looking upstream.	
pkazi_f_20131001_059.jpg

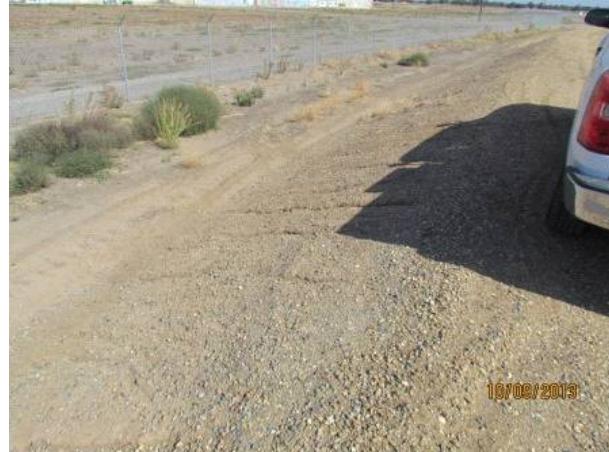
Levee Mile Report Line	38
Start Levee Mile	5.89
End Levee Mile	5.89
Location	Land Side
Category	Earthen Levee
Item	Erosion / Bank Caving
Runoff was found on the landside slope of the levee looking upstream.	
pkazi_f_20131019_952.JPG

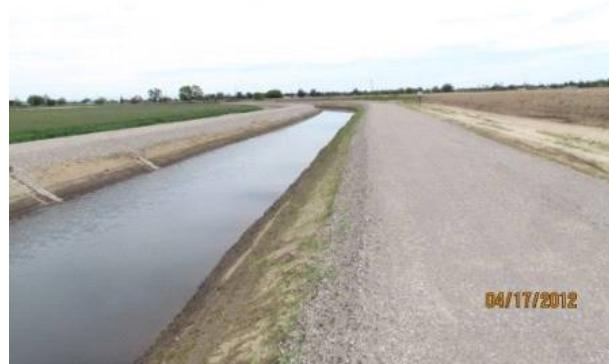
Levee Mile Report Line	40
Start Levee Mile	6.24
End Levee Mile	6.24
Location	Land Side
Category	Earthen Levee
Item	Encroachments
A 20 feet wide channel was dug on the landside of the levee looking upstream.	
pkazi_f_20131001_029.jpg

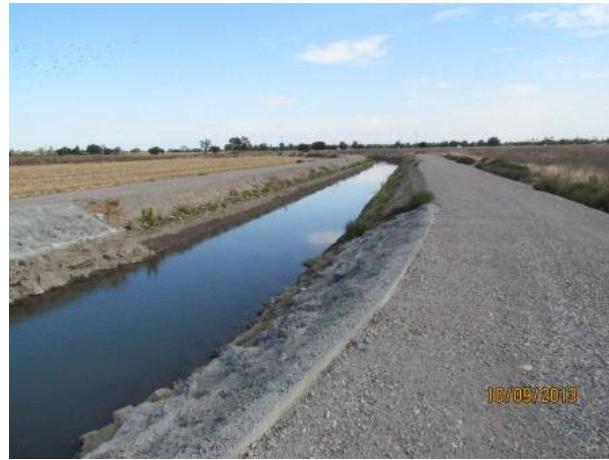
Levee Mile Report Line	40
Start Levee Mile	6.24
End Levee Mile	6.24
Location	Land Side
Category	Earthen Levee
Item	Encroachments
Updated picture of the ditch near the landside toe of the levee looking upstream.	
pkazi_f_20131019_953.JPG

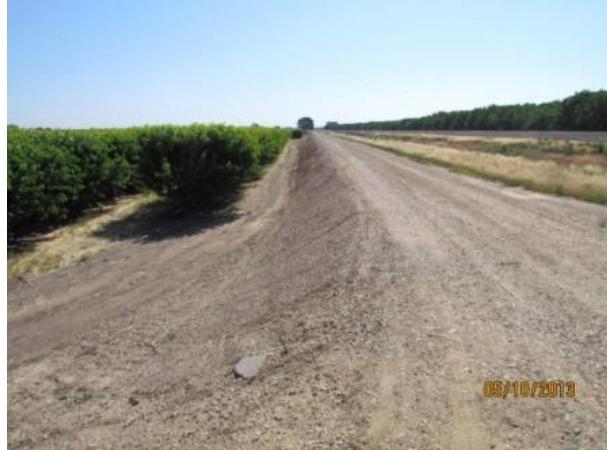
Levee Mile Report Line	47
Start Levee Mile	8.28
End Levee Mile	8.28
Location	Land Side
Category	Earthen Levee
Item	Slope Stability
Agricultural tilling on the landside toe of the levee was repaired by the LMA.	
pkazi_f_20131001_042.JPG

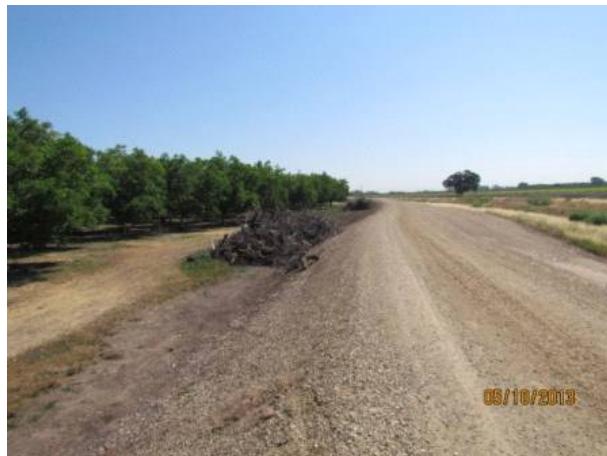
Levee Mile Report Line	49
Start Levee Mile	8.82
End Levee Mile	8.82
Location	Land Side
Category	Earthen Levee
Item	Encroachments
Prunings were found on the landside of the levee looking upstream.	
pkazi_f_20131001_049.JPG

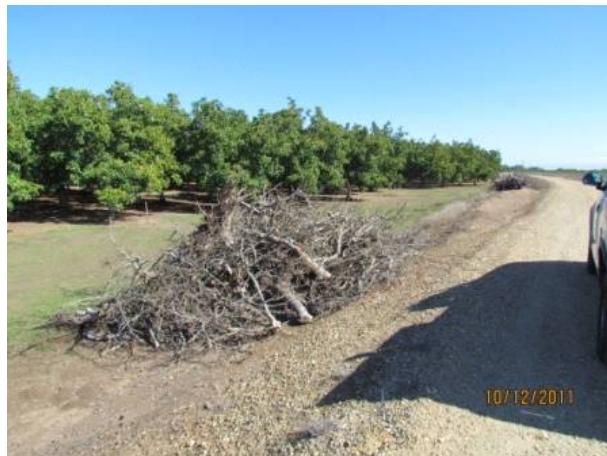
Levee Mile Report Line	50
Start Levee Mile	8.87
End Levee Mile	8.87
Location	Land Side
Category	Earthen Levee
Item	Encroachments
Prunings were found on the landside of the levee looking upstream.	
pkazi_f_20131001_032.jpg

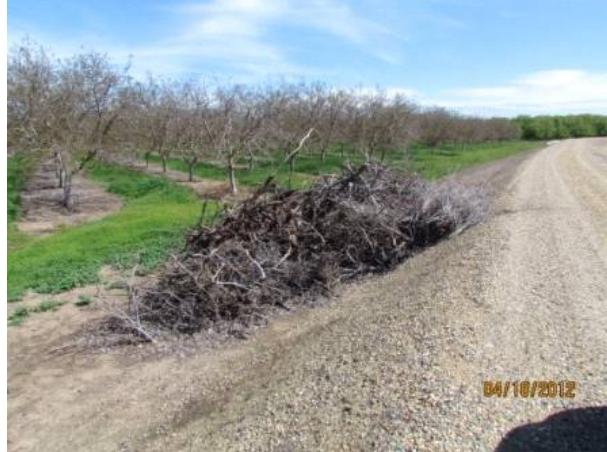
Levee Mile Report Line	51
Start Levee Mile	9.06
End Levee Mile	9.06
Location	Land Side
Category	Earthen Levee
Item	Encroachments
Prunings were found on the landside of the levee looking upstream.	
pkazi_f_20131001_081.jpg

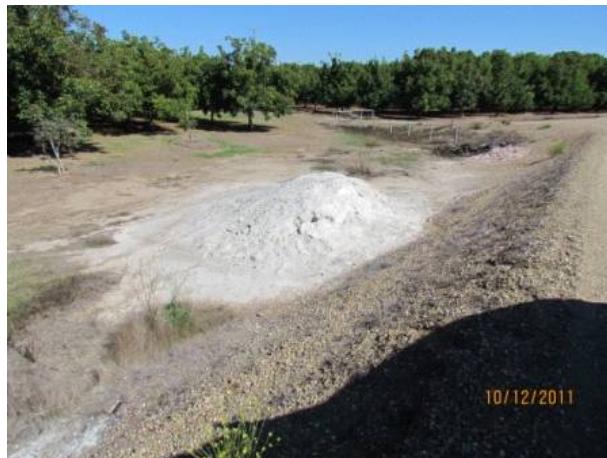
Levee Mile Report Line	52
Start Levee Mile	9.15
End Levee Mile	9.15
Location	Land Side
Category	Earthen Levee
Item	Encroachments
Ash pile was found on the landside of the levee looking upstream.	
pkazi_f_20131001_030.jpg

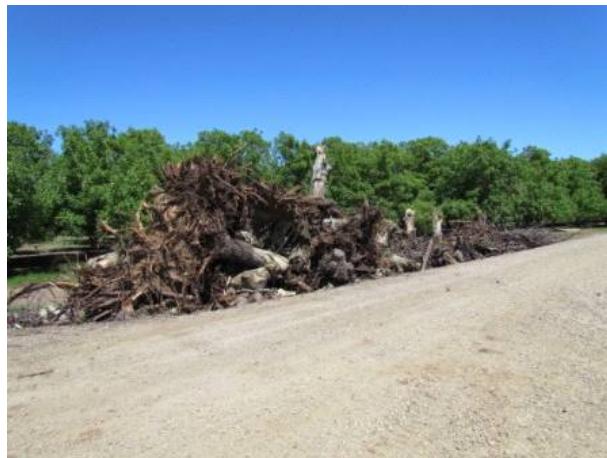
Levee Mile Report Line	53
Start Levee Mile	9.18
End Levee Mile	9.18
Location	Land Side
Category	Earthen Levee
Item	Encroachments
Burn piles on the landside of the levee. The picture was taken from the crown of the levee looking upstream.	
pkazi_f_20131001_033.jpg

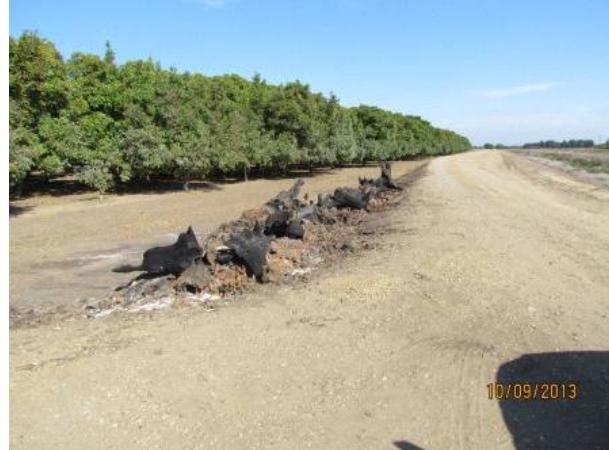
Levee Mile Report Line	53
Start Levee Mile	9.18
End Levee Mile	9.18
Location	Land Side
Category	Earthen Levee
Item	Encroachments
Updated picture of the burning piles on the landside of the levee looking upstream.	
pkazi_f_20131019_954.JPG

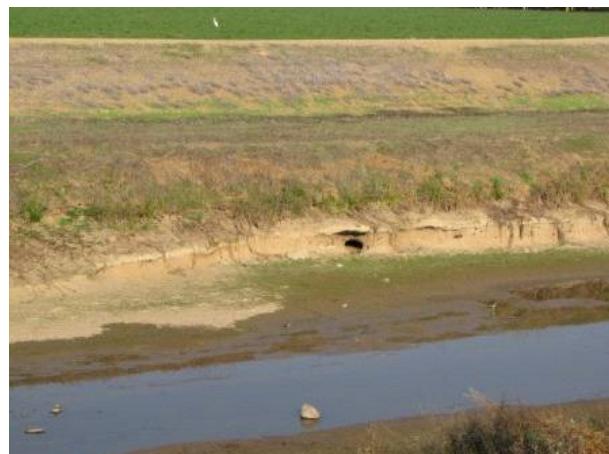
Levee Mile Report Line	55
Start Levee Mile	9.65
End Levee Mile	9.65
Location	Water Side
Category	Earthen Levee
Item	Animal Control
View of a large hole and several smaller holes from across the channel.	
pkazi_f_20131001_064.jpg

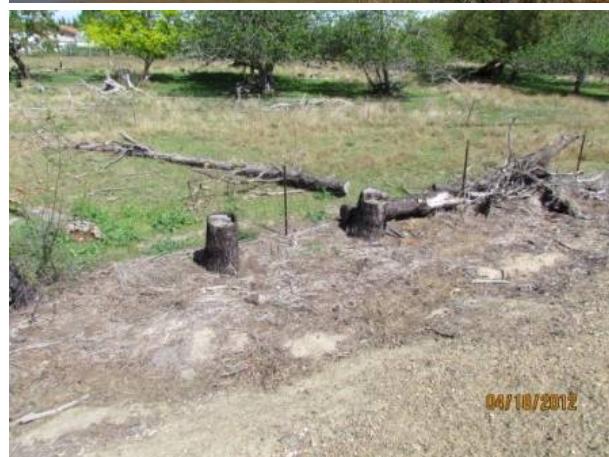
Levee Mile Report Line	60
Start Levee Mile	10.23
End Levee Mile	10.23
Location	Land Side
Category	Earthen Levee
Item	Trim / Thin Trees
Tree stumps were found on the landside of the levee looking upstream.	
pkazi_f_20131001_044.jpg

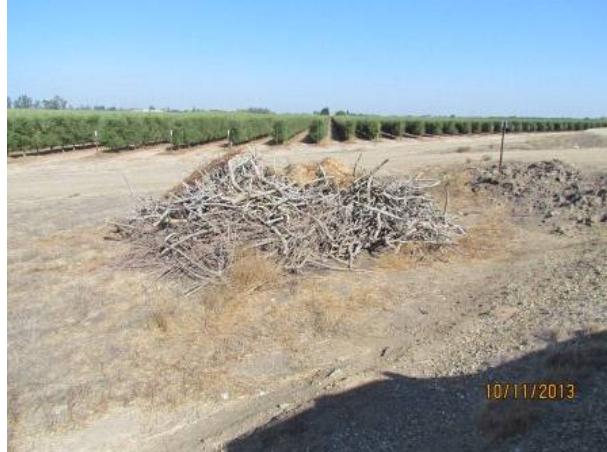
Levee Mile Report Line	65
Start Levee Mile	11.73
End Levee Mile	11.73
Location	Land Side
Category	Earthen Levee
Item	Encroachments
Prunings were found on the landside of the levee looking upstream.	
pkazi_f_20131019_955.JPG

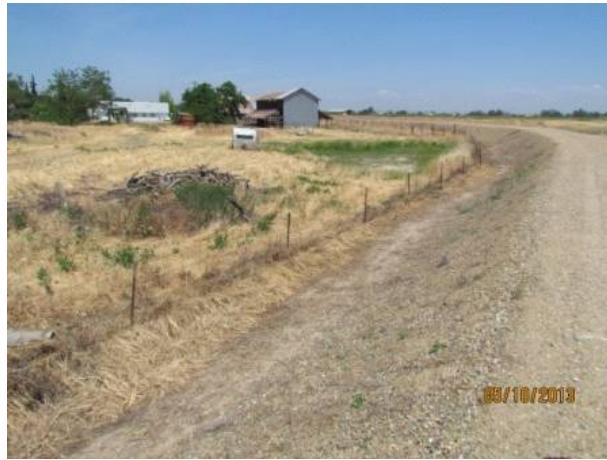
Levee Mile Report Line	67
Start Levee Mile	12.41
End Levee Mile	13.22
Location	Land Side
Category	Earthen Levee
Item	Encroachments
Fences were found on the landside toe of the levee looking upstream.	
pkazi_f_20131001_070.JPG

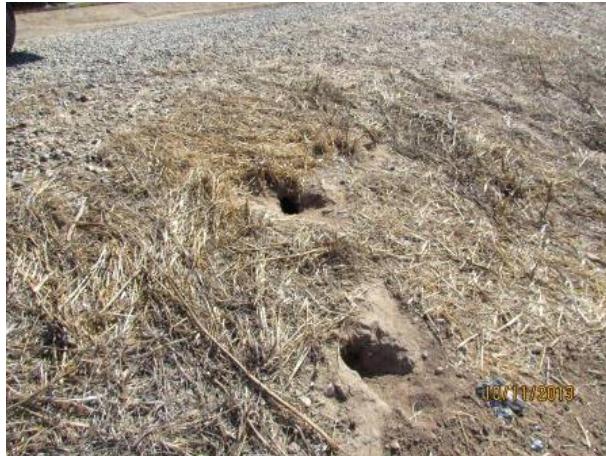
Levee Mile Report Line	69
Start Levee Mile	12.90
End Levee Mile	12.90
Location	Land Side
Category	Earthen Levee
Item	Animal Control
Animal holes were found on the landside slope of the levee looking downstream.	
pkazi_f_20131019_956.JPG

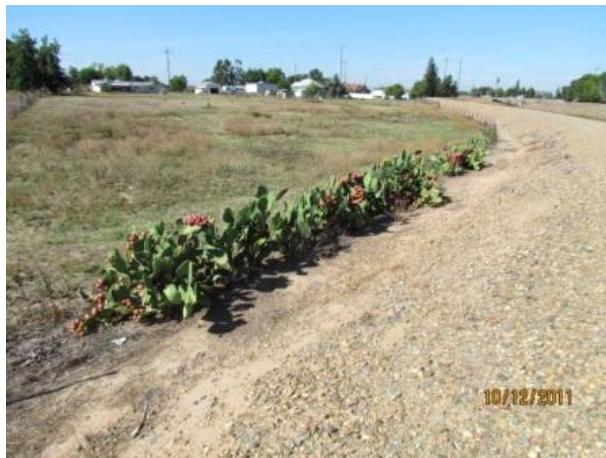
Levee Mile Report Line	70
Start Levee Mile	13.06
End Levee Mile	13.06
Location	Land Side
Category	Earthen Levee
Item	Vegetation
Cacti were found on the toe of landside of the levee looking upstream.	
pkazi_f_20131001_043.jpg

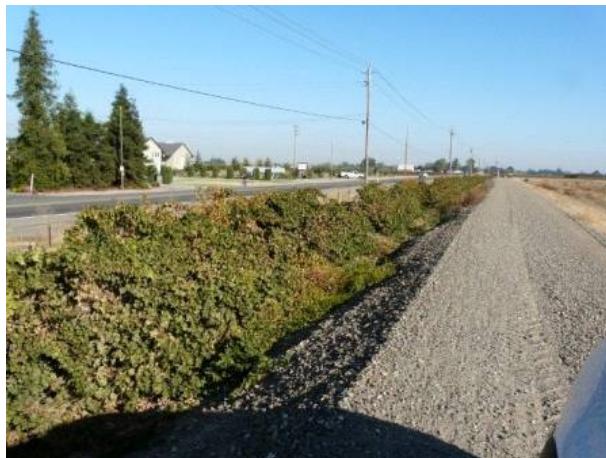
Levee Mile Report Line	71
Start Levee Mile	13.39
End Levee Mile	13.51
Location	Land Side
Category	Earthen Levee
Item	Encroachments
Grape vines within 10' from landside toe of levee from LM 13.39 to 13.51.	
pkazi_f_20131001_039.JPG

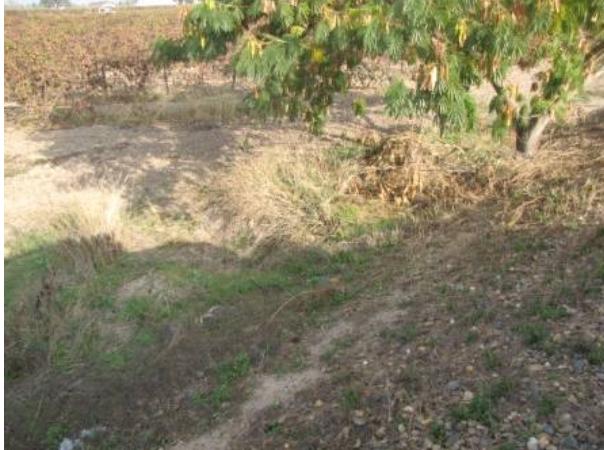
pkazi\_f\_20131001\_058.jpg

View of a pit along the landward levee toe looking upstream.

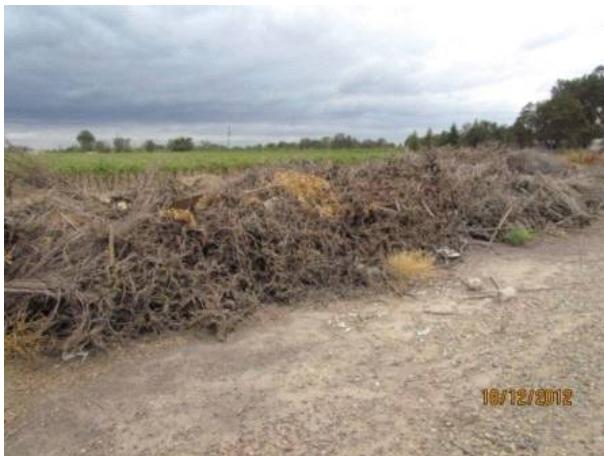
pkazi\_f\_20131001\_053.jpg

Levee Mile Report Line	74
Start Levee Mile	13.96
End Levee Mile	13.96
Location	Land Side
Category	Earthen Levee
Item	Encroachments

Prunings were found on the landside of the levee. The picture was taken from the crown looking towards the toe of the levee.

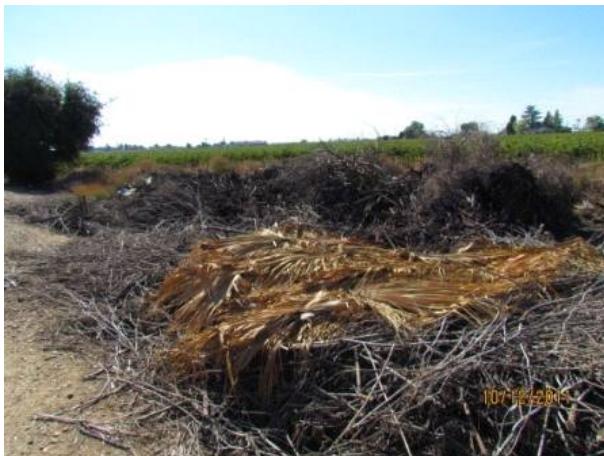
pkazi\_f\_20131001\_078.jpg

Levee Mile Report Line	75
Start Levee Mile	13.98
End Levee Mile	13.98
Location	Land Side
Category	Earthen Levee
Item	Encroachments

Pruning and debris were found on the landside of the levee looking downstream.

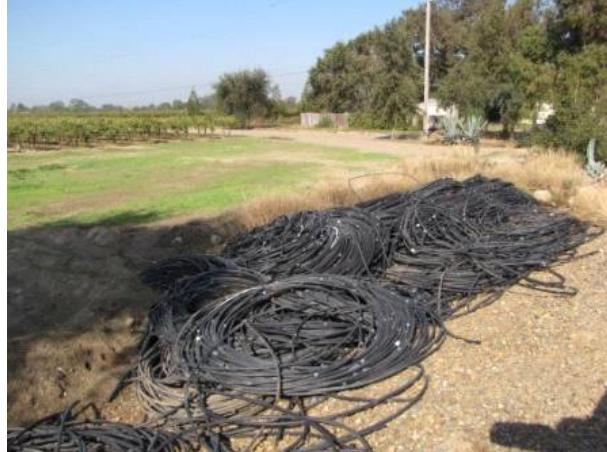
Levee Mile Report Line	76
Start Levee Mile	13.99
End Levee Mile	13.99
Location	Land Side
Category	Earthen Levee
Item	Encroachments
View of irrigation pipe on the landward slope.	
<i>pkazi_f_20131001_084.jpg</i>

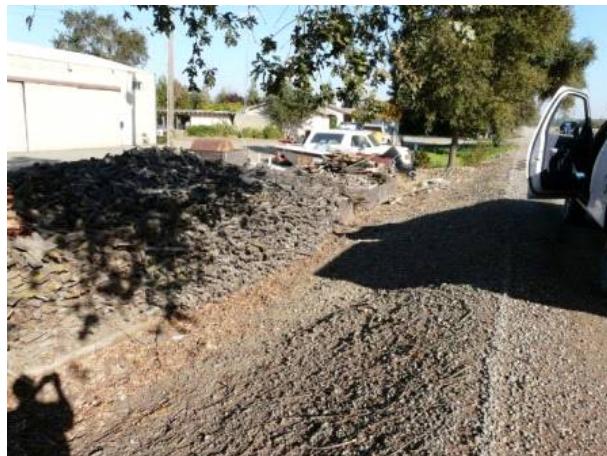
Levee Mile Report Line	77
Start Levee Mile	14.08
End Levee Mile	14.08
Location	Land Side
Category	Earthen Levee
Item	Encroachments
Move firewood to outside of 10' from landside toe of levee at LM 14.08.	
<i>pkazi_f_20131001_040.JPG</i>

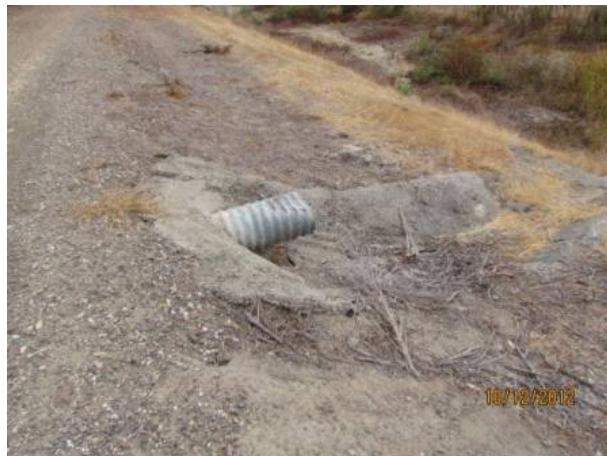
Levee Mile Report Line	80
Start Levee Mile	14.40
End Levee Mile	14.40
Location	Water Side
Category	Earthen Levee
Item	Encroachments
A pipe was found on the waterside shoulder of the levee looking upstream.	
<i>pkazi_f_20131001_067.jpg</i>

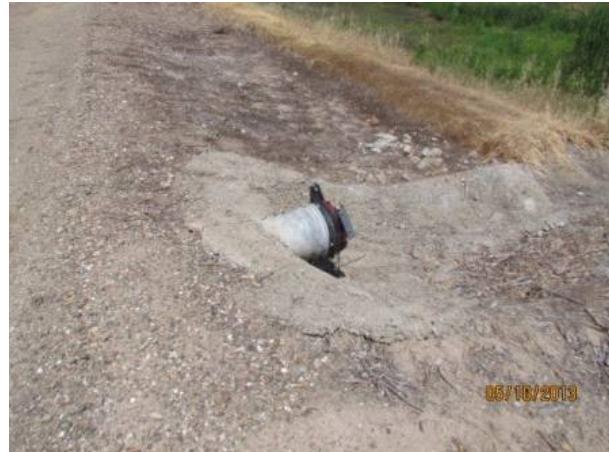
Levee Mile Report Line	80
Start Levee Mile	14.40
End Levee Mile	14.40
Location	Water Side
Category	Earthen Levee
Item	Encroachments
A flap gate was installed on a pipe located on the waterside slope of the levee looking upstream.	
pkazi_f_20131001_068.JPG

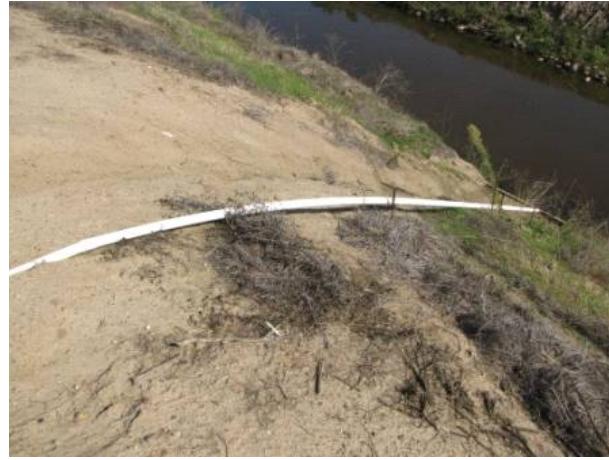
Levee Mile Report Line	82
Start Levee Mile	14.77
End Levee Mile	14.77
Location	Water Side
Category	Earthen Levee
Item	Encroachments
View of a pipe a landowner placed in the access road and waterward slope to pump water from the channel to irrigate their garden.	
pkazi_f_20131001_085.jpg

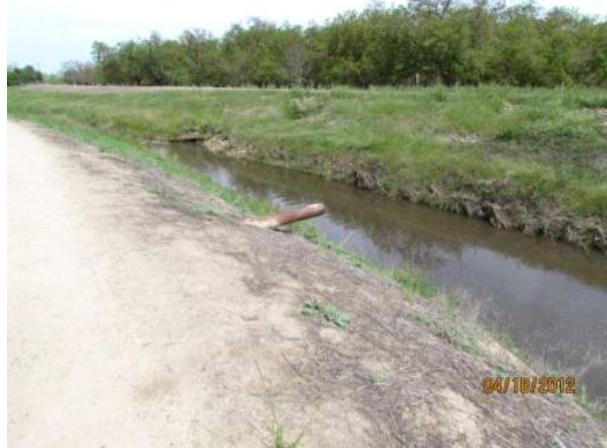
Levee Mile Report Line	83
Start Levee Mile	14.79
End Levee Mile	14.79
Location	Water Side
Category	Earthen Levee
Item	Encroachments
A corroded pipe was found on the waterside of the levee looking upstream.	
pkazi_f_20131001_054.jpg

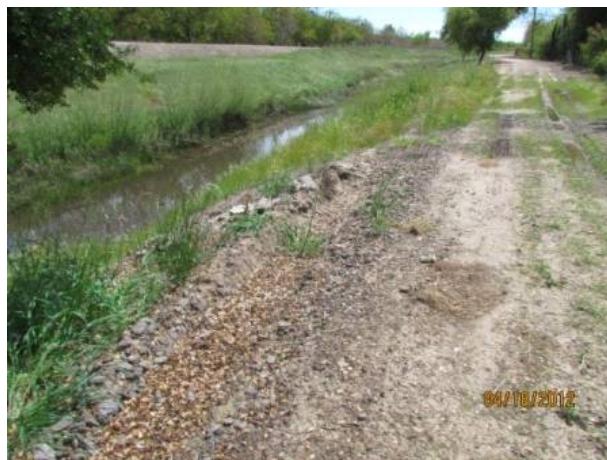
Levee Mile Report Line	84
Start Levee Mile	14.89
End Levee Mile	14.89
Location	Crown
Category	Earthen Levee
Item	Crown Surface / Depressions / Rutting
Crown depression was found on the waterside shoulder of the levee looking downstream.	
pkazi_f_20131001_055.jpg

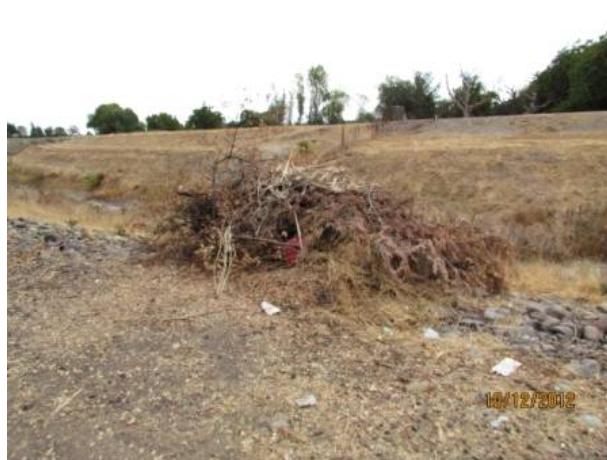
Levee Mile Report Line	85
Start Levee Mile	14.90
End Levee Mile	14.90
Location	Water Side
Category	Earthen Levee
Item	Encroachments
Prunings were found on the waterside of the levee looking upstream.	
pkazi_f_20131001_069.jpg

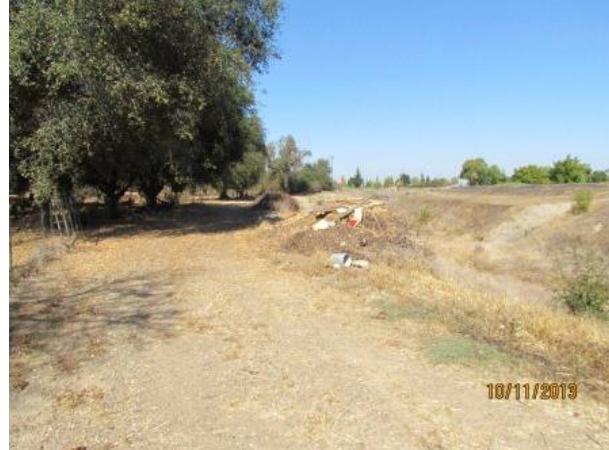
Levee Mile Report Line	85
Start Levee Mile	14.90
End Levee Mile	14.90
Location	Water Side
Category	Earthen Levee
Item	Encroachments
Updated picture of the prunings on the waterside shoulder of the levee looking upstream.	
pkazi_f_20131019_958.JPG

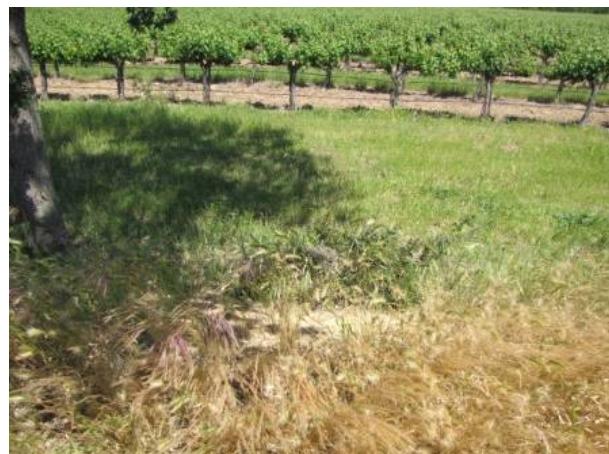
Levee Mile Report Line	87
Start Levee Mile	15.72
End Levee Mile	15.72
Location	Land Side
Category	Earthen Levee
Item	Trim / Thin Trees
View of a stump in the landward slope.	
pkazi_f_20131001_050.jpg
